**HUDSON RIVER BASIN  
SANDGATE**

**LAKE MADELEINE  
VT 00007**

**PHASE I INSPECTION REPORT  
NATIONAL DAM INSPECTION PROGRAM**

**SEPTEMBER 1973**

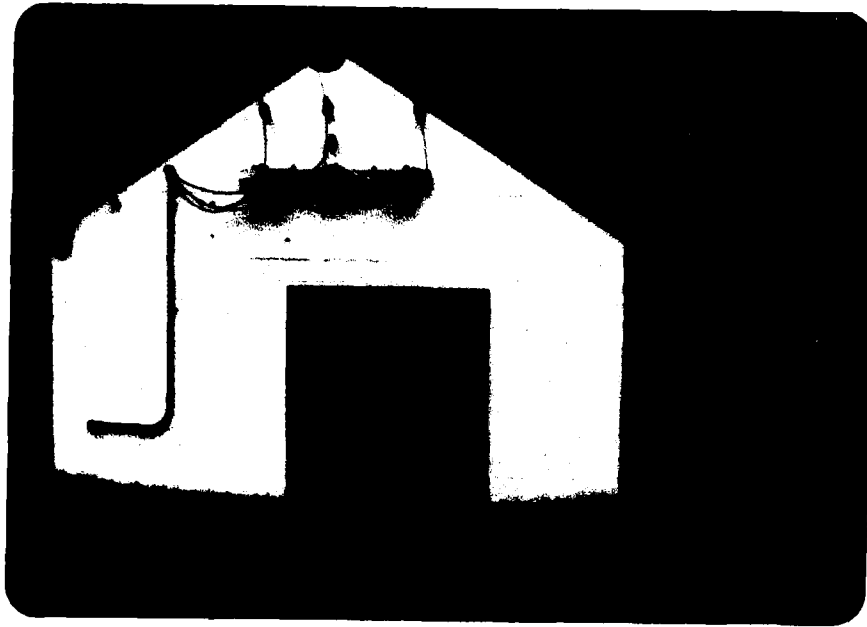
#9 POWER HOUSE No. 1 LOCATED APPROXIMATELY 11,000 FEET  
DOWNSTREAM OF LAKE MADELEINE DAM.
